2018 REGULAR INSPECTION REPORT
RED VALLEY DAM
NJ DAM FILE NO. 28-025
AT MONMOUTH COUNTY BRIDGE U-1

Inspection Performed on
November 28, 2018

January 10, 2019
FPA No. 2284.005

Re: 2018 Regular Inspection of
Red Valley Dam
NJ Dam File No. 28-025
At Monmouth County Bridge U-1
Upper Freehold Township, Monmouth County, New Jersey
FPA No. 2284.005

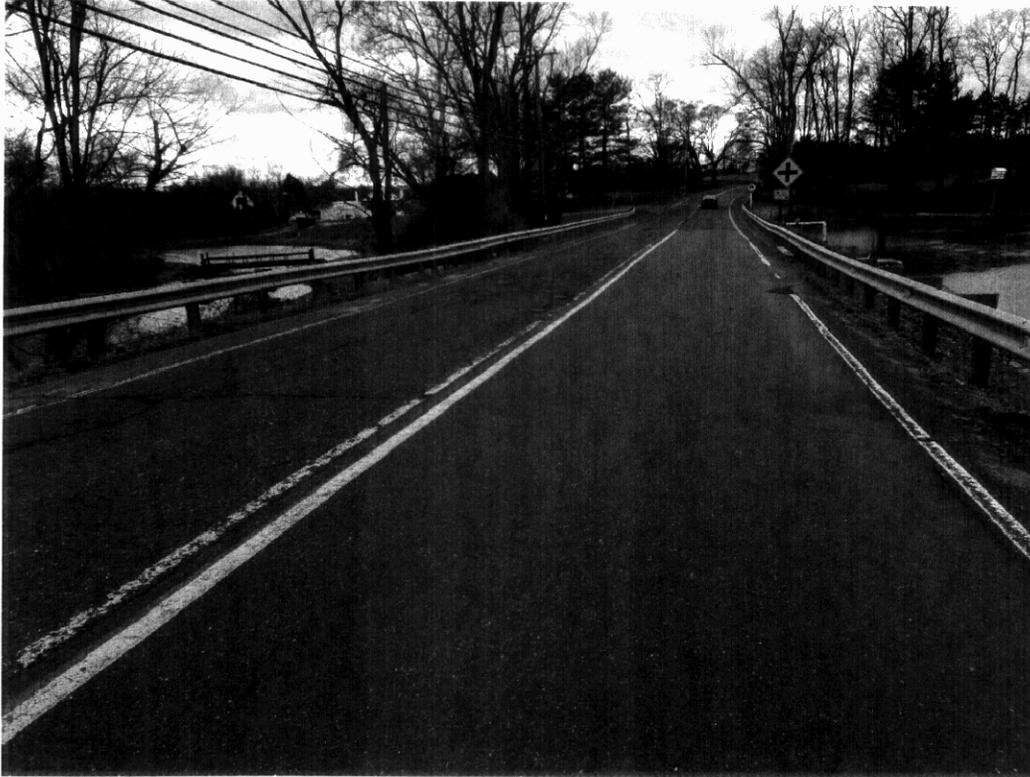
Photo 1: Dam embankment crest.
Note: Allentown Lakewood Road, CR 526 traverses the dam crest.

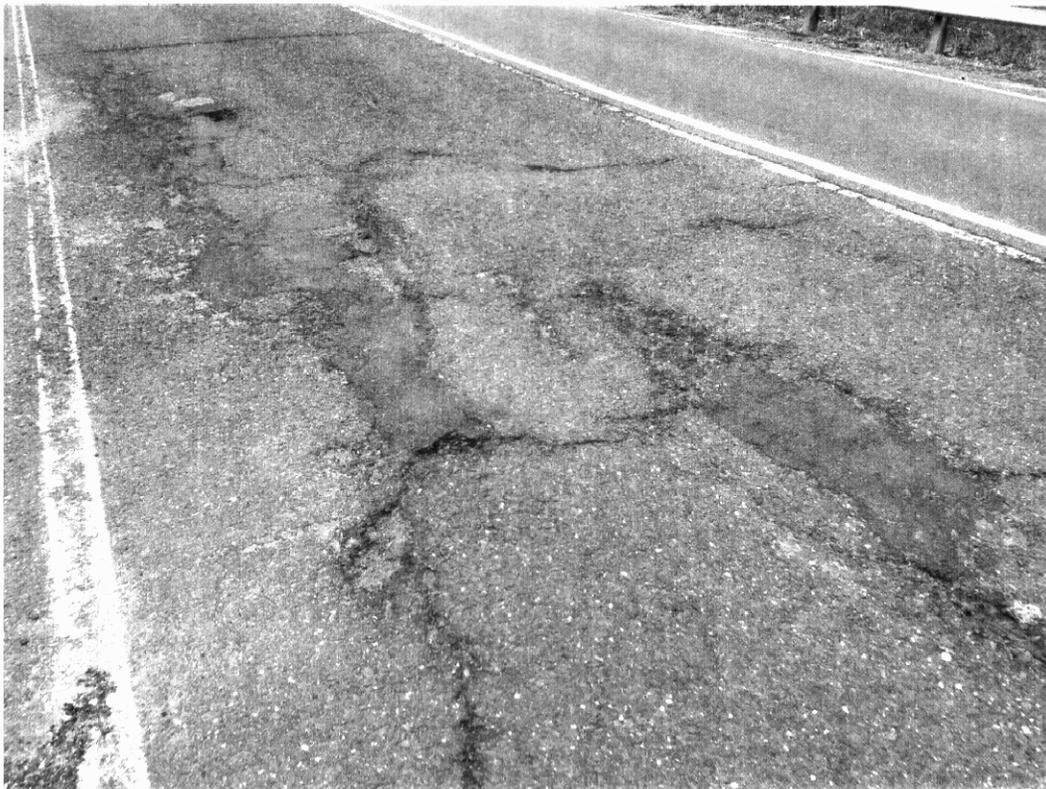
Surface Cracks: ***Minor cracks observed in roadway pavement.***

Photo 2: Deteriorated, cracked asphalt pavement.
Note: Allentown Lakewood Road, CR 526 traverses the dam crest.

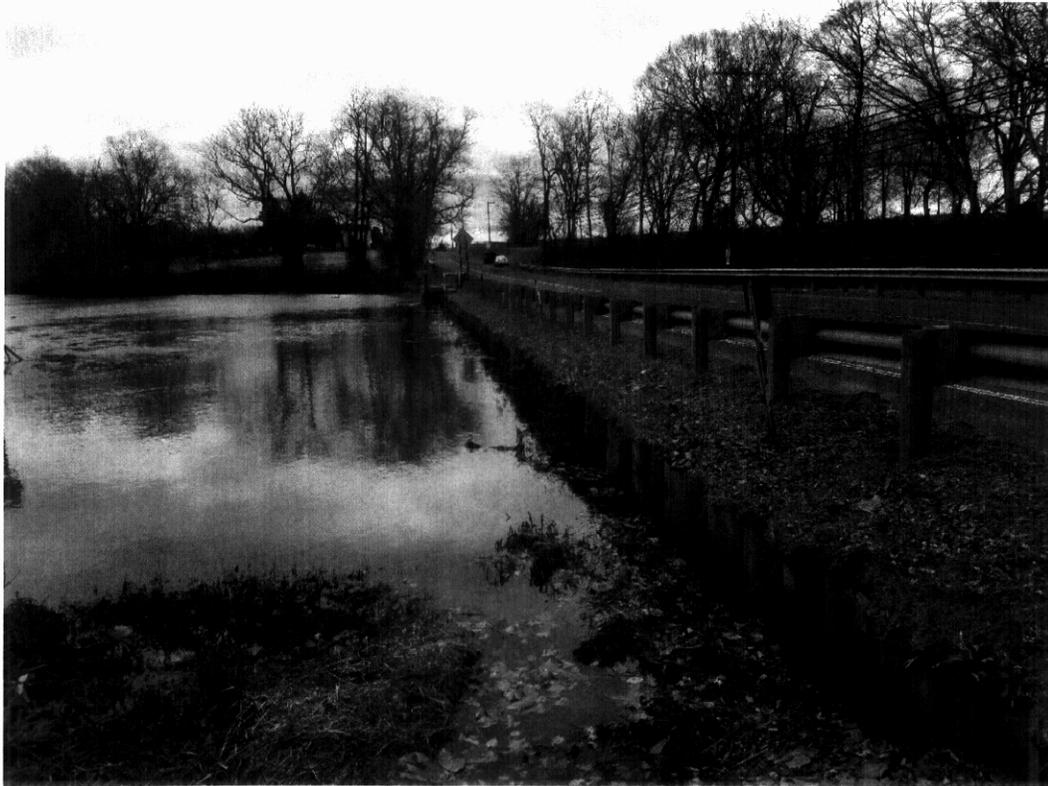
Trees, Undesirable Growth or Debris, Animal Burrows: ***There are small caliper trees, brush and vegetation located on the upstream slope along the steel sheeting.***

***Photo 3: Upstream slope / steel sheet pile bulkhead.
Note: Trees, brush, and woody vegetation located along the steel sheeting.***

- **Small trees and brush should be removed from the crest of the dam embankment.**
- **Concrete repairs of spillway wing wall and bridge abutment cracks, as well as spalls in low level outlet support.**
- **Debris should be removed from spillway crest.**

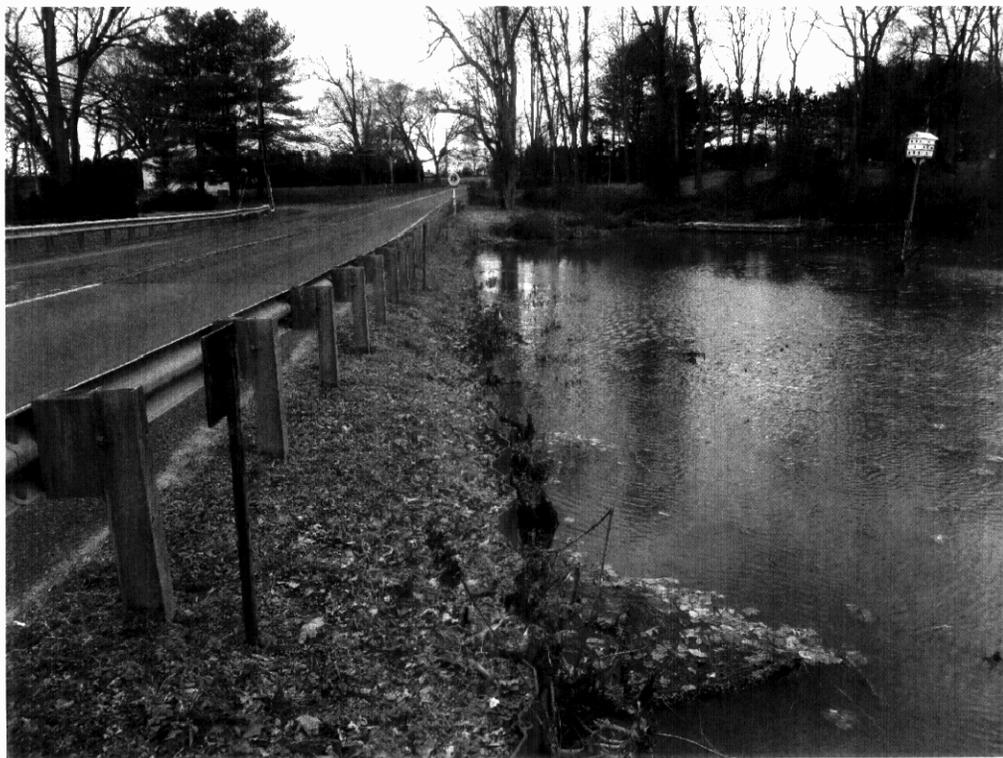
Unusual Conditions: ***Erosion of the upstream slope near the right abutment observed during previous inspection, obscured by vegetation during this inspection.***

***Photo 4: Upstream slope to the right of the spillway structure.
Note: Minor erosion of the upstream slope was noted near the right abutment.***

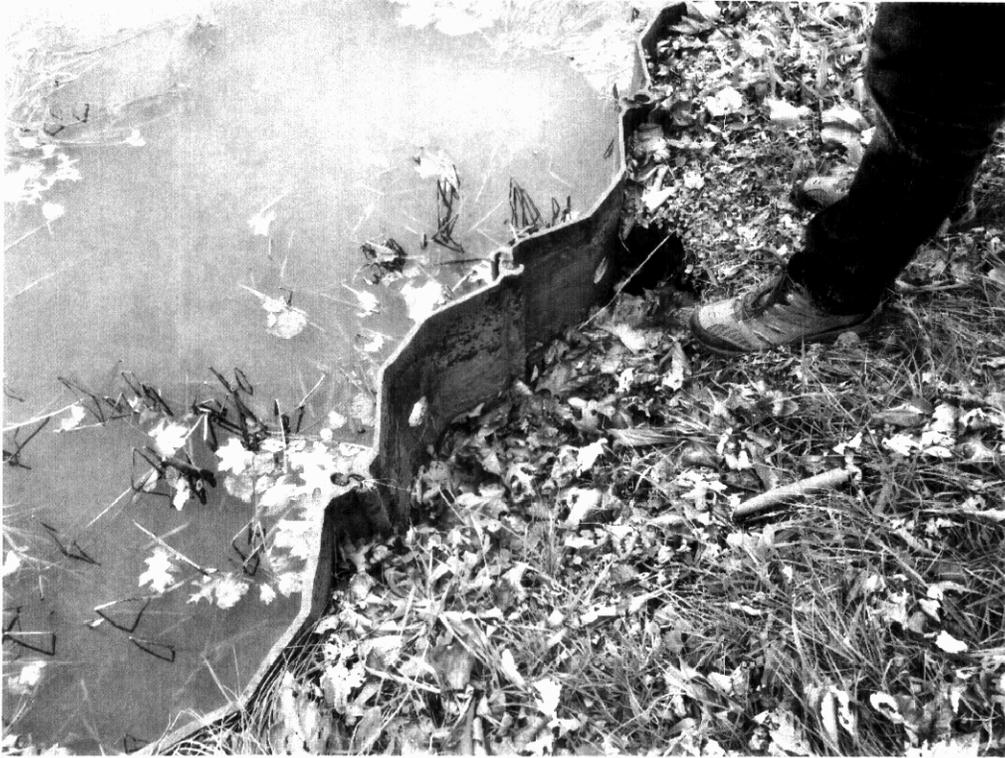
Sloughing, Subsidence or Depressions: ***Minor subsidence observed adjacent to the vertical steel sheeting observed during previous inspection, obscured by vegetation during this inspection.***

*Photo 5: Steel sheeting on upstream slope to the right of the spillway structure.
Note: Depressions observed along upstream steel sheeting.*

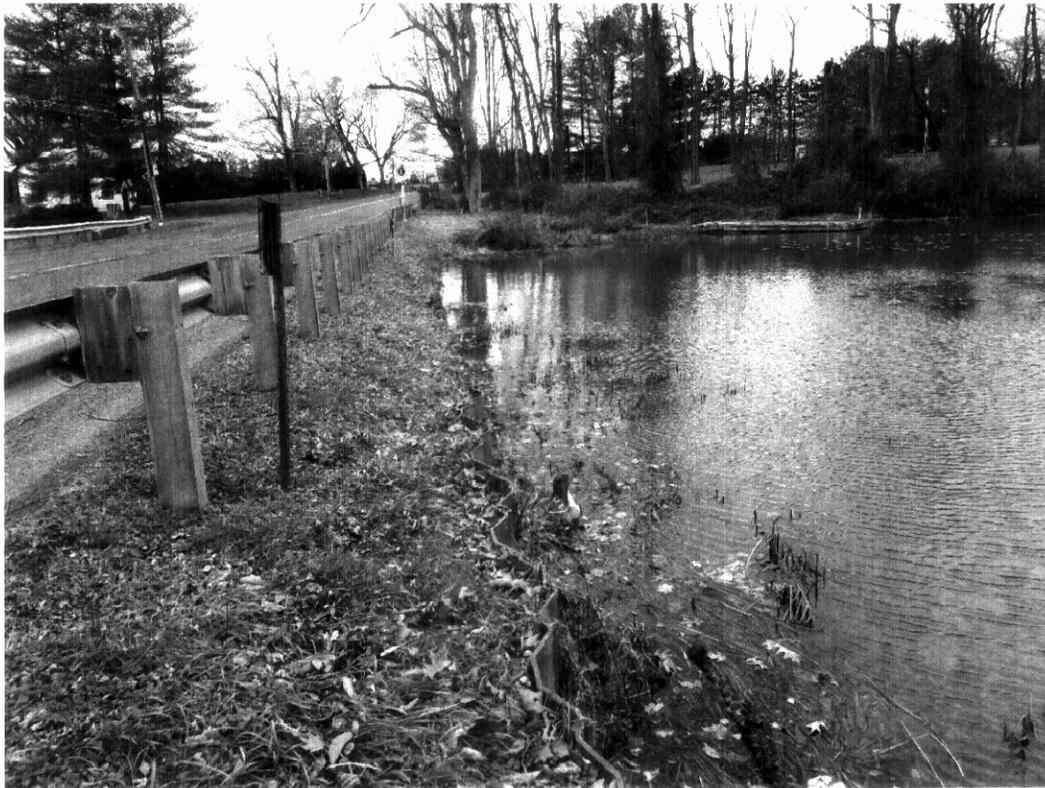
Photo 6: Steel sheeting on upstream slope to the right of the spillway structure.

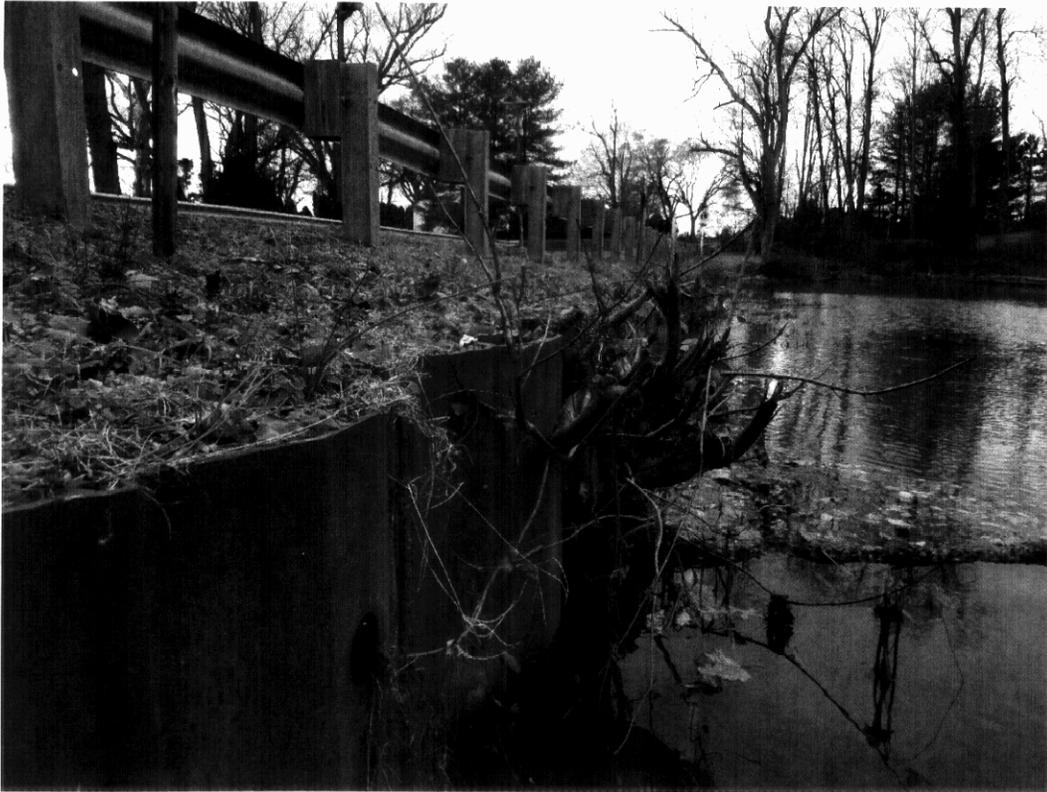
Slope Protection: ***Vertical steel sheeting. Some tree growth at the steel sheeting.***

*Photo 7: Steel sheeting on upstream slope to the right of the spillway structure.
Note: Trees established through the sheeting.*

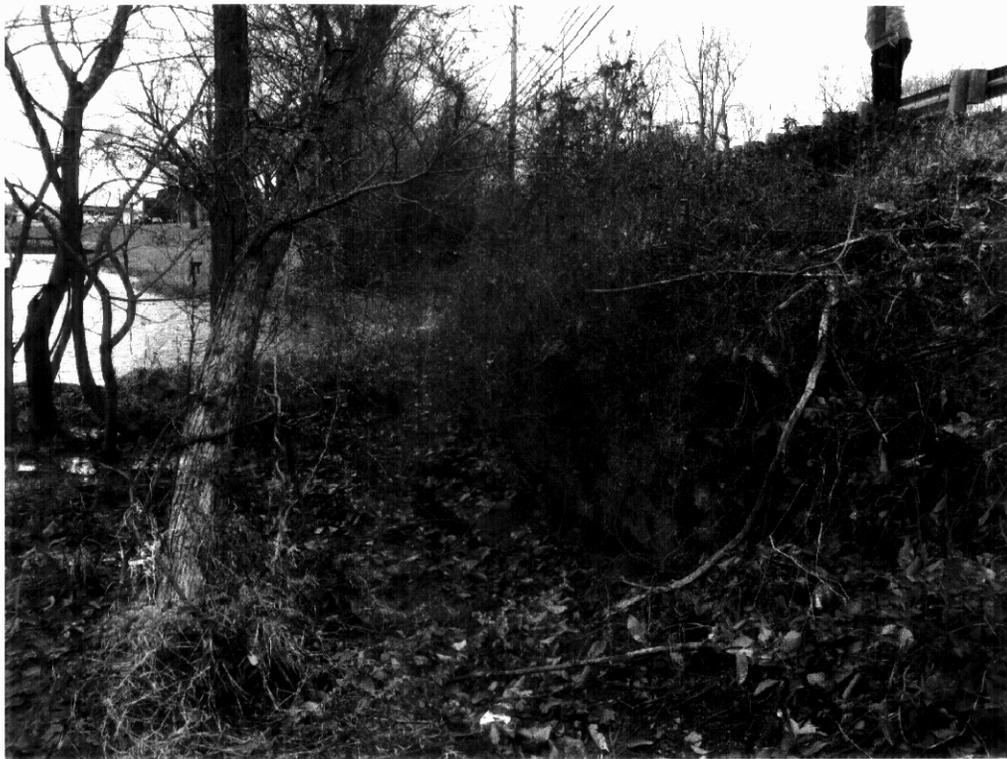
*Photo 8: Downstream slope to the left of the spillway structure.
Note: Trees, brush, and woody vegetation located near the left abutment.*

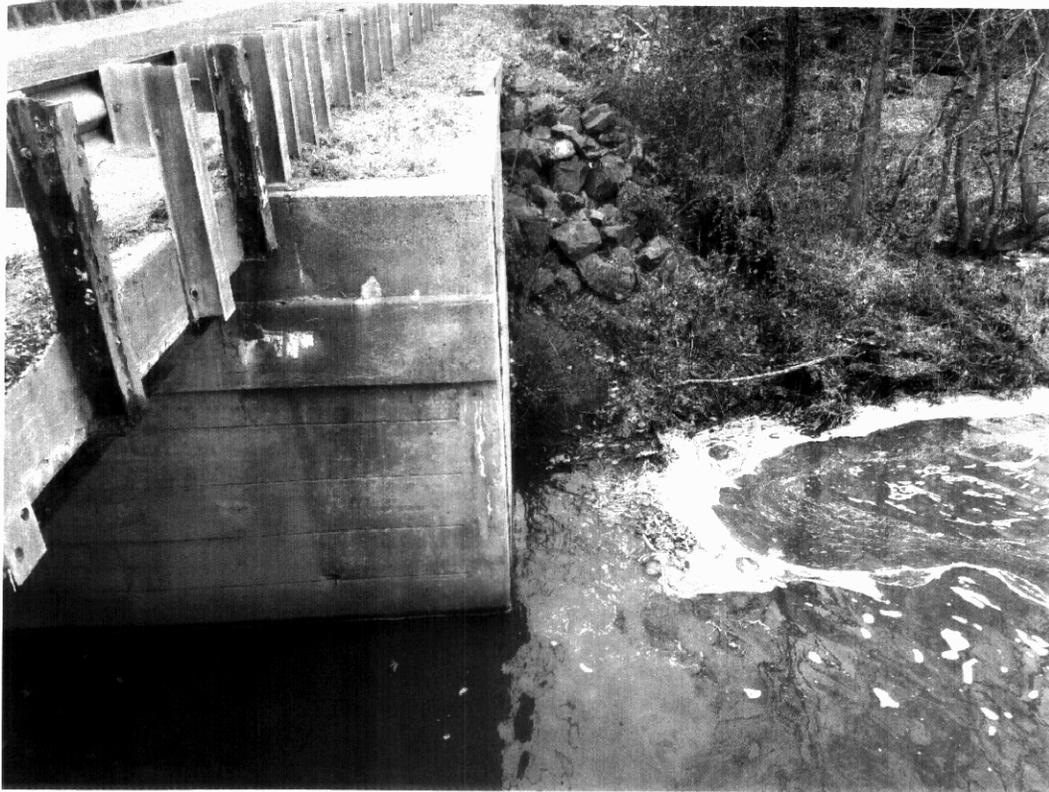
Photo 9: Downstream slope at spillway structure

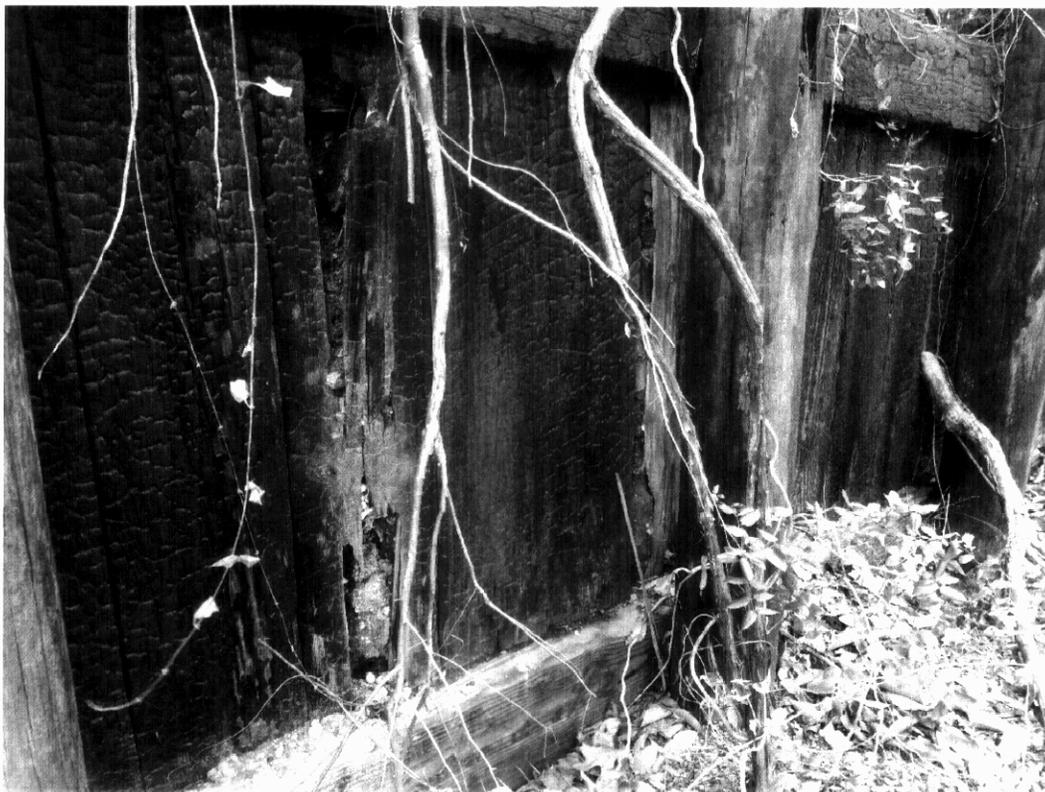
*Photo 10: Timber sheeting along the downstream slope to the left of the primary spillway structure.
Note: The sheeting is heavily deteriorated.*

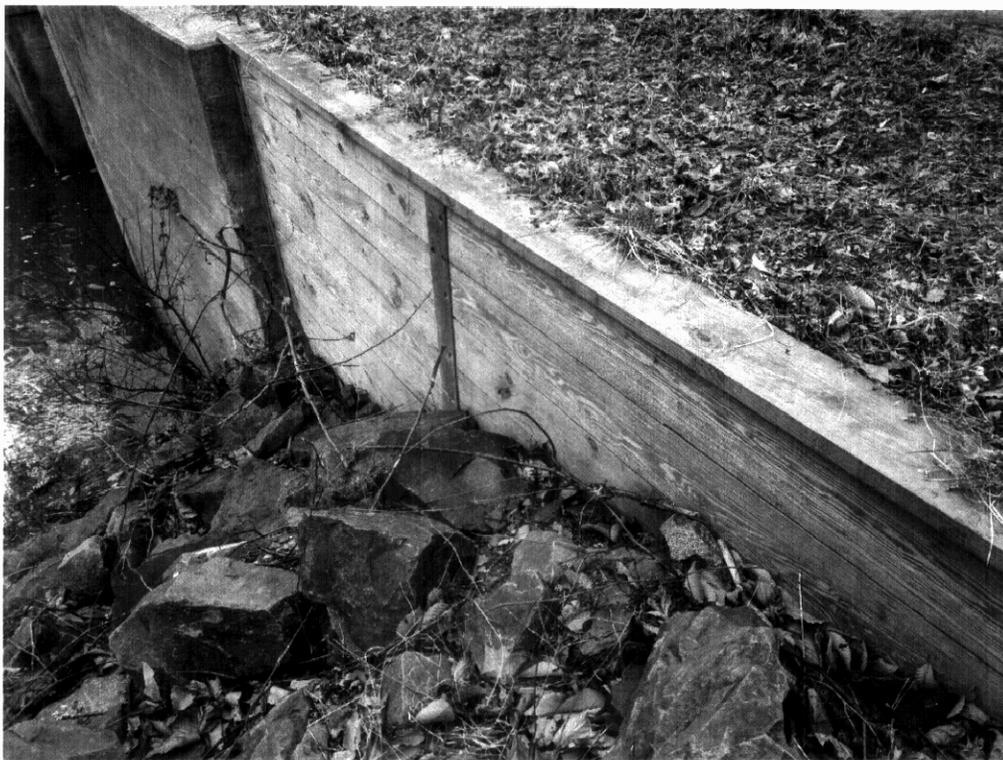
Sloughing, Subsidence or Depressions: **Asphalt observed at these locations as an attempt to prevent future erosion due to roadway runoff. A timber retaining wall and riprap stone has been installed to stabilize the area.**

*Photo 11: Timber sheeting located on the downstream slope.
Note: Recently installed timber retaining wall and riprap observed to the left of the exit channel.*

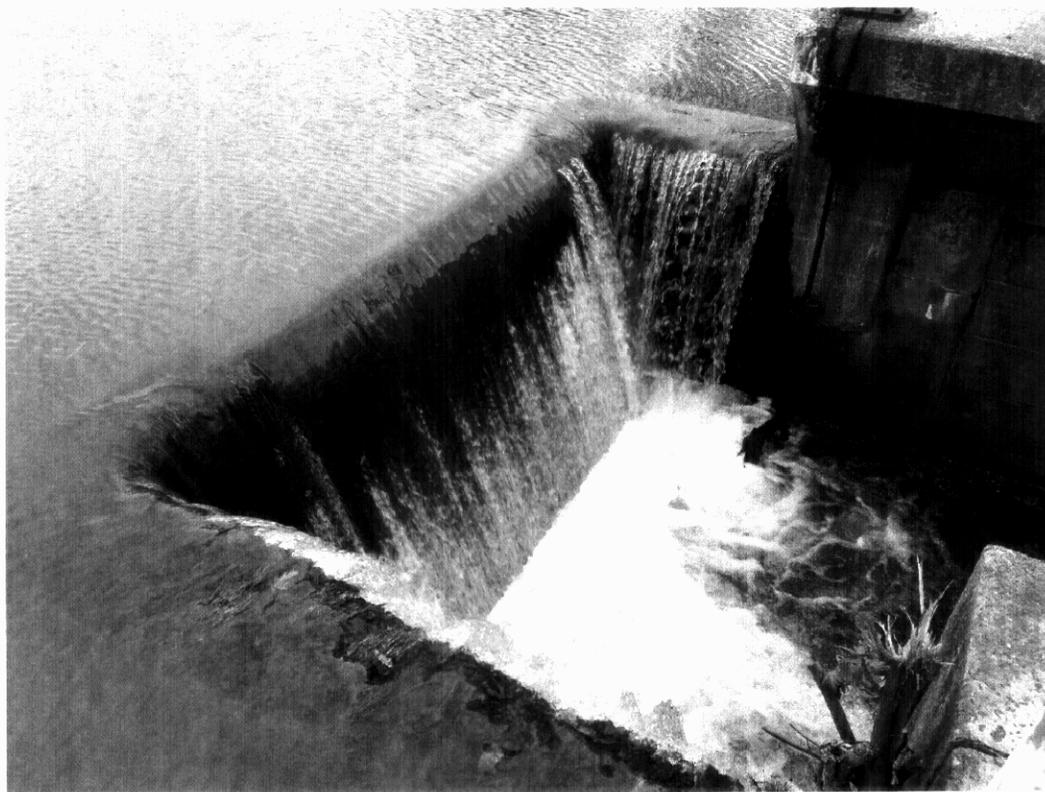
Photo 12: Overview of primary spillway structure.

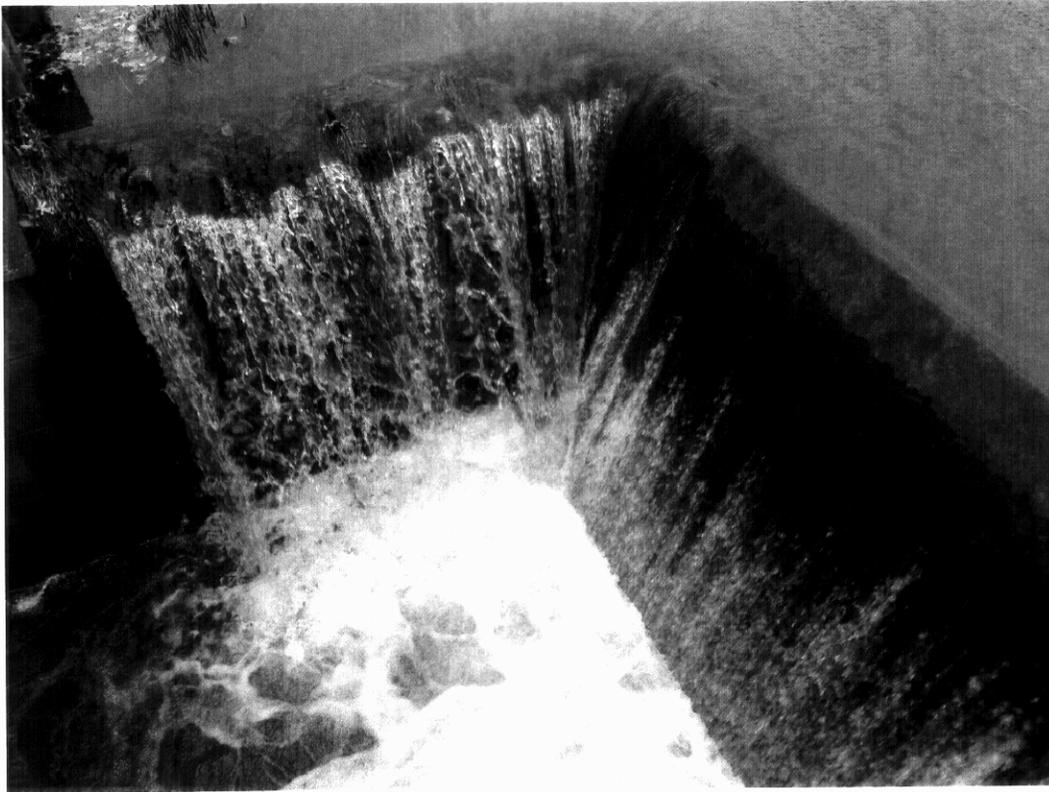
Photo 13: Primary concrete drop box spillway structure.

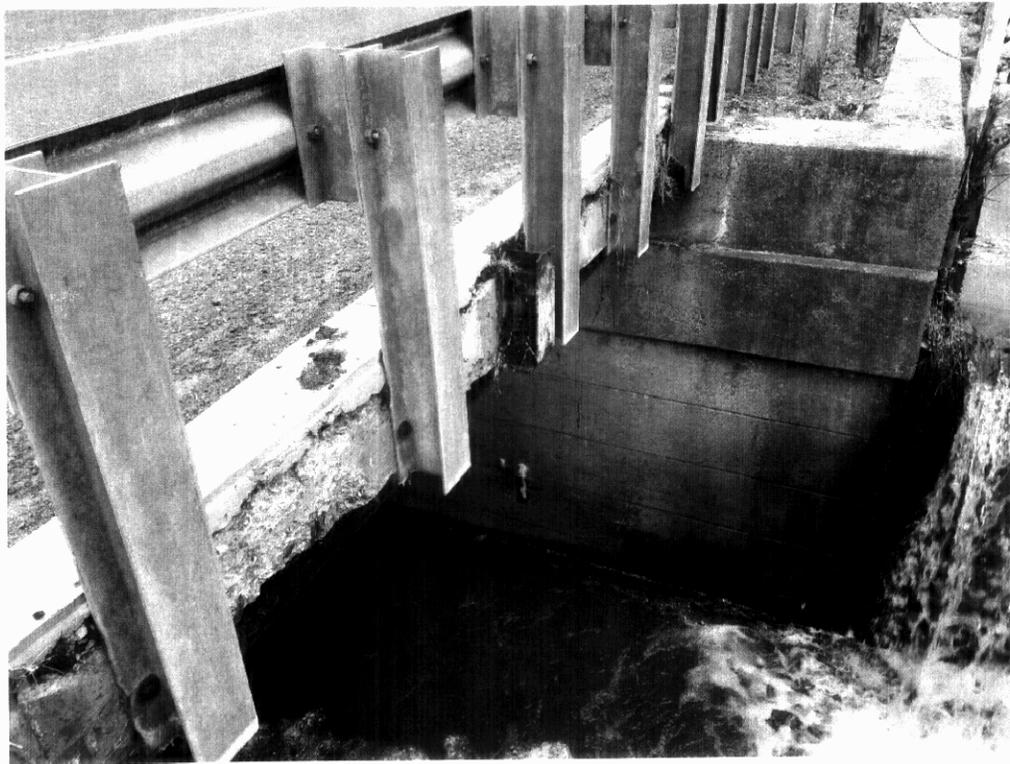
Photo 14: Right side of primary concrete drop box spillway structure and right bridge abutment

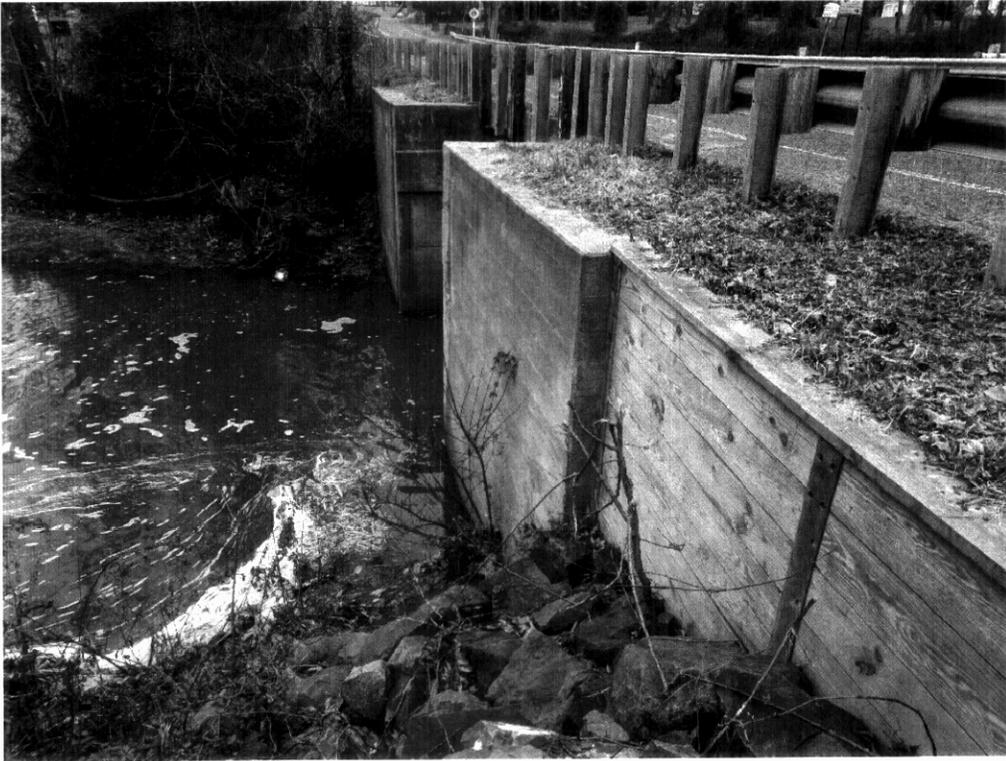
Photo 15: Downstream slope to the left of the spillway structure.
Note: Recently installed timber retaining wall and riprap observed to the left of the exit channel.

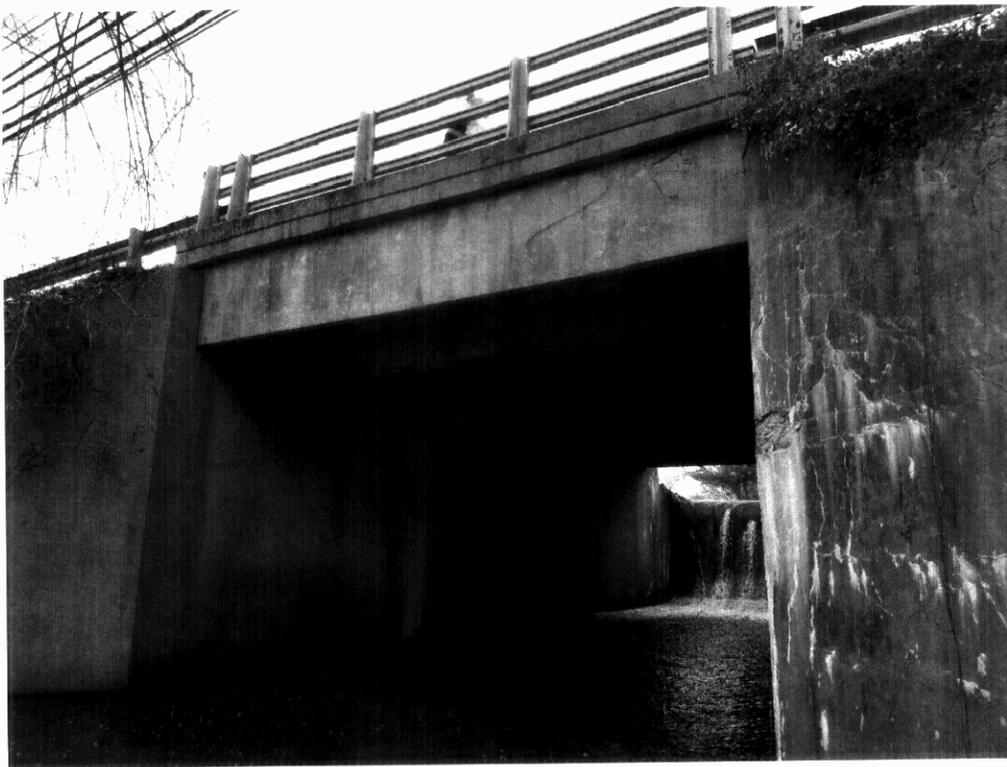
Condition of Material: **The concrete wing walls are cracked vertically at the interface with the abutments.**

Signs of Movement: **The wing walls exhibit signs of movement at the concrete abutments.**

Photo 16: Concrete wing walls downstream of bridge abutments.
Note: Vertical cracks in the concrete wing walls at bridge abutments.

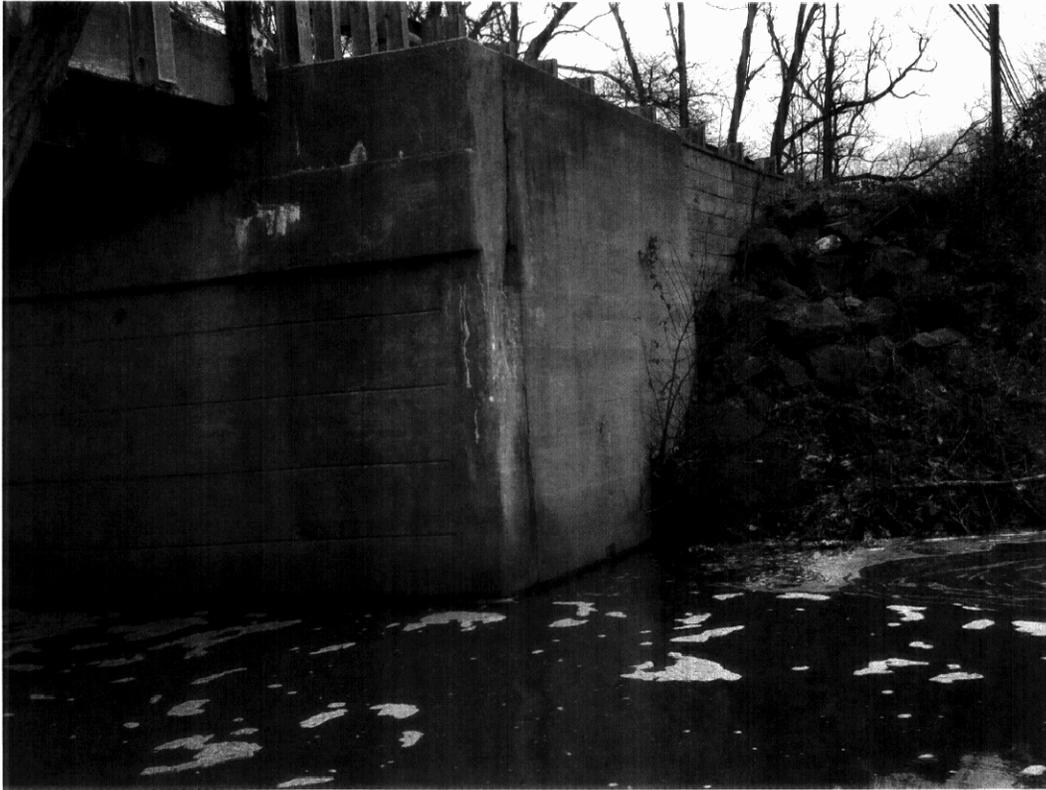
*Photo 17: Crack located in the left downstream wing wall at the downstream face.
Note: Vertical cracks extend from the top down the face of the wall, typical both sides.*

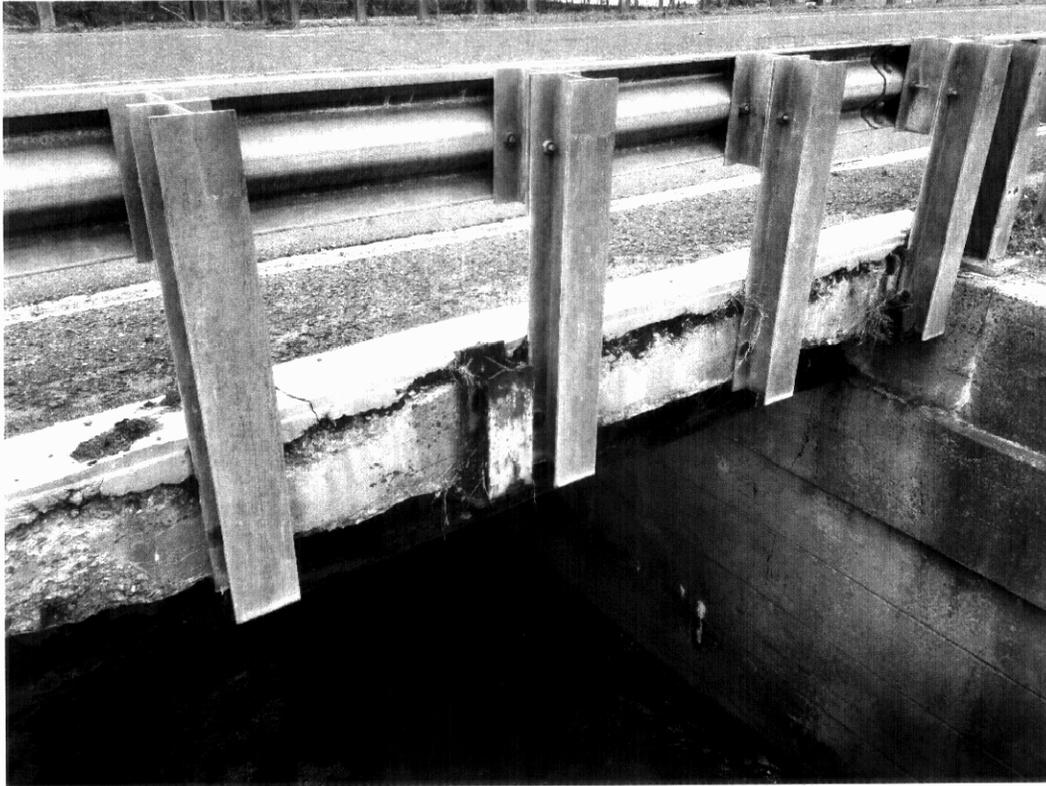
Description: *Flow travels downstream between the concrete bridge abutments into the exit channel.*
Condition of Material: *Fair.*
Signs of Movement: *None observed.*
Joints: *No problems noted.*
Seepage: *None observed.*
Unusual Conditions: *The steel bridge beams appear to be rusted and deteriorated.*

*Photo 18: Upstream fascia steel bridge beam.
Note: The steel bridge beam exhibits some signs of rust and deterioration.*

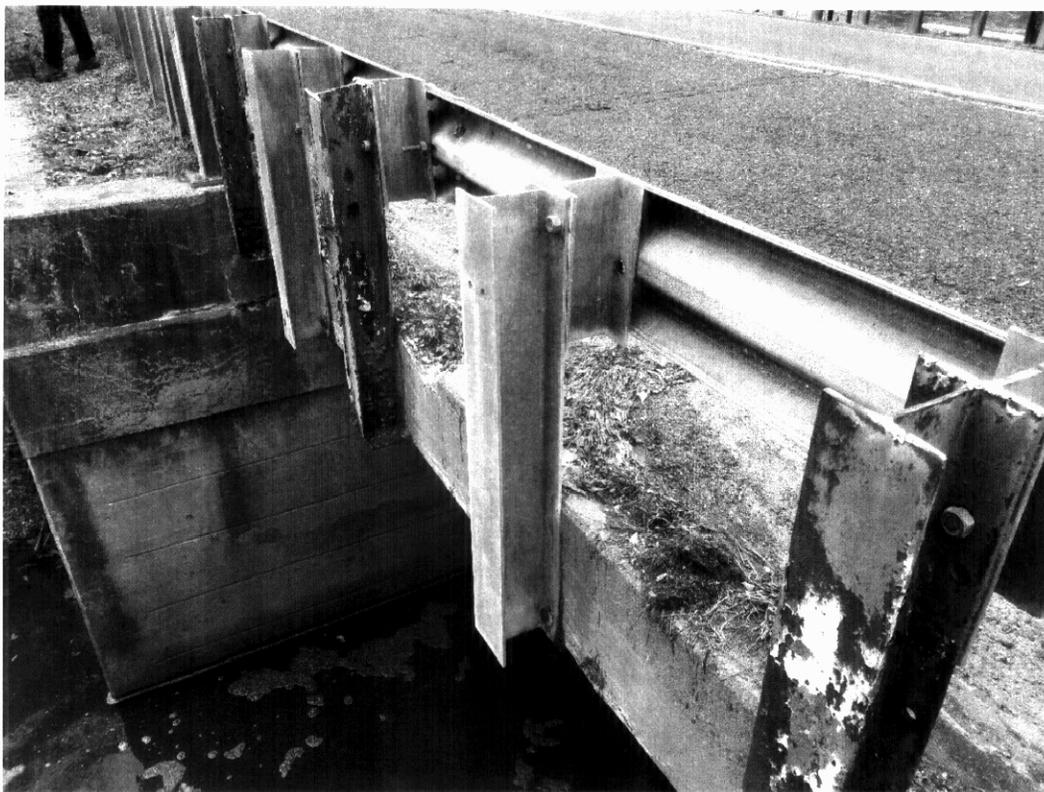
Photo 19: Downstream fascia of bridge.

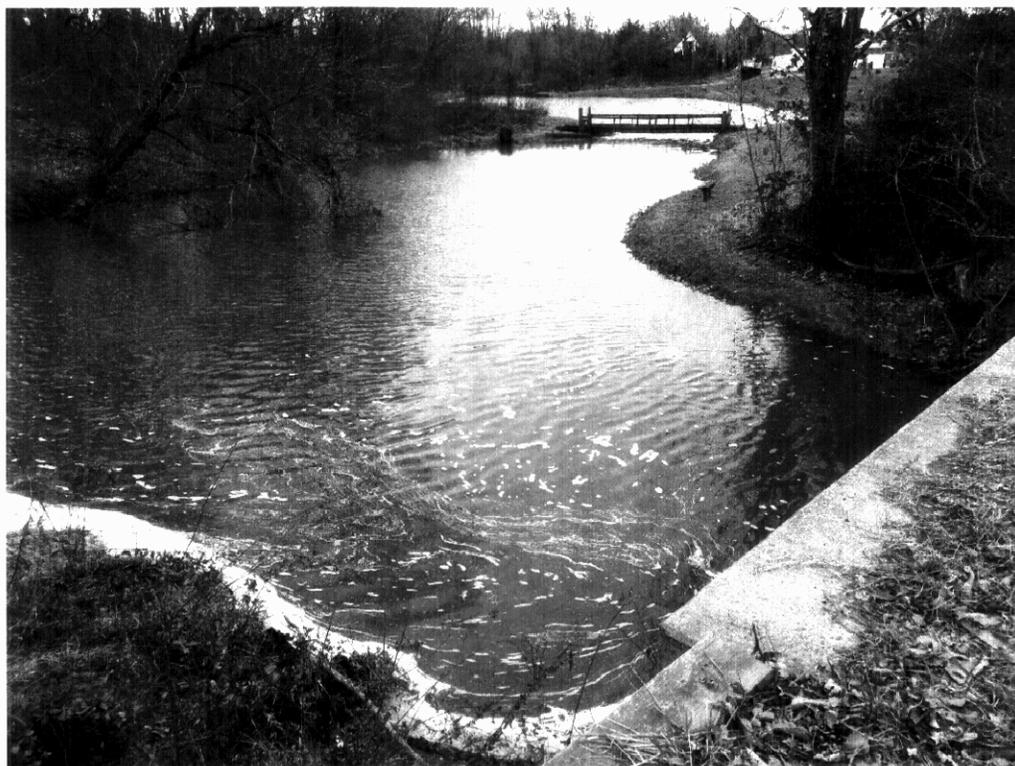
Vegetation (Trees, Bushes): *Channel is clear of vegetation.*
Debris: *None observed.*
Channel Side-Slope Stability: *Side slopes are stable.*
Erosion: *Minor bank erosion observed.*
Unusual Conditions: *None observed.*

Photo 20: Exit channel.

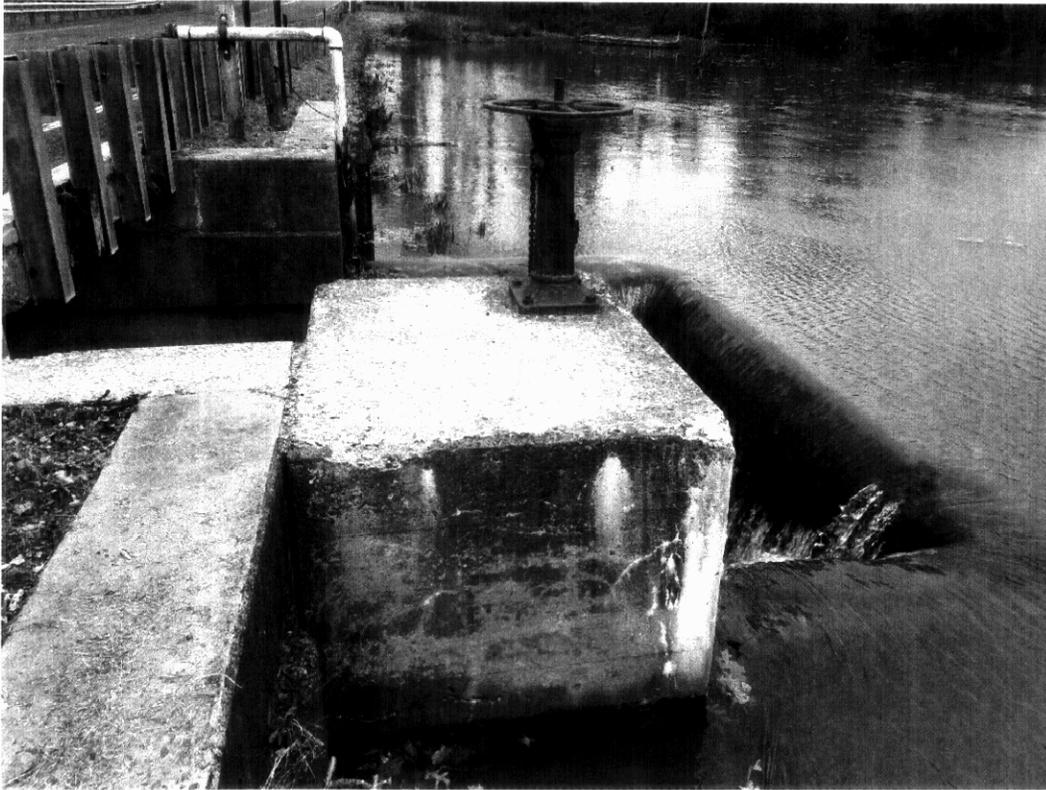
Description: *A 24 inch diameter steel pipe with gate through lower portion of the spillway headwall.*
Condition: *The gate was submerged by tailwater at the time of inspection. The gate stem is rusted and deteriorated.*
Trash Rack: *None observed.*
Leakage: *None observed – pipe outlet submerged by tailwater at the time of inspection.*

Photo 21: Low level outlet gate operator.

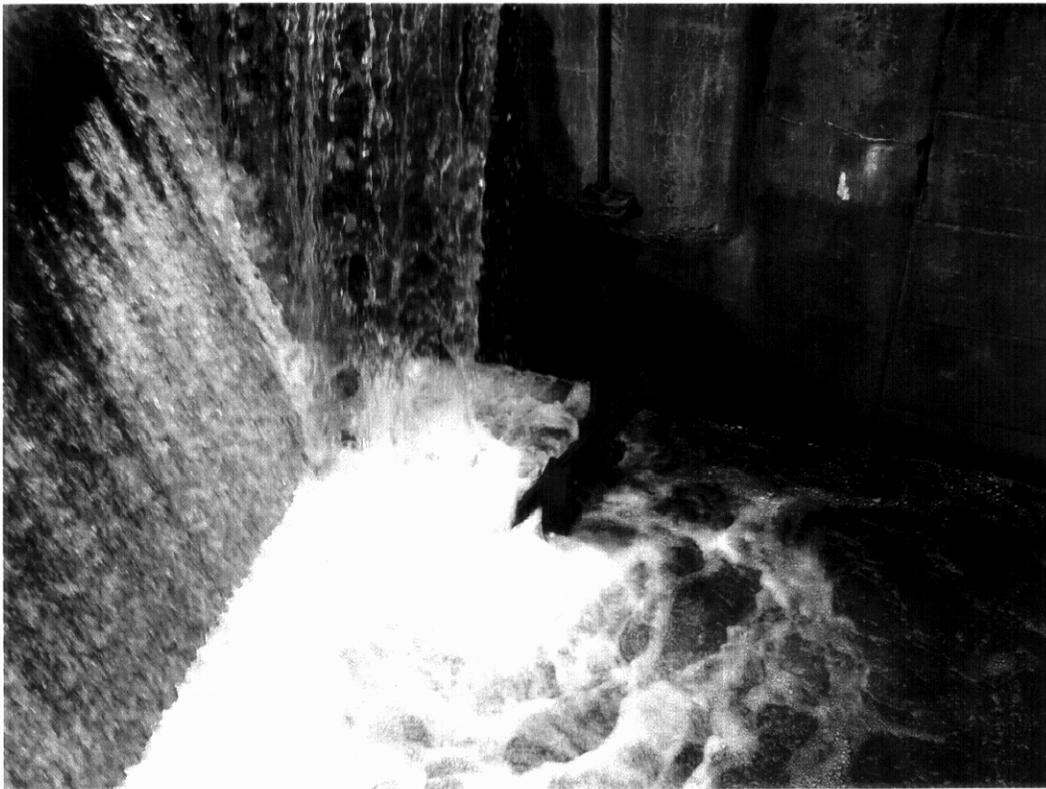
Photo 22: Low level outlet gate.

Note: The floor of the drop box spillway structure obscured by tailwater and debris.

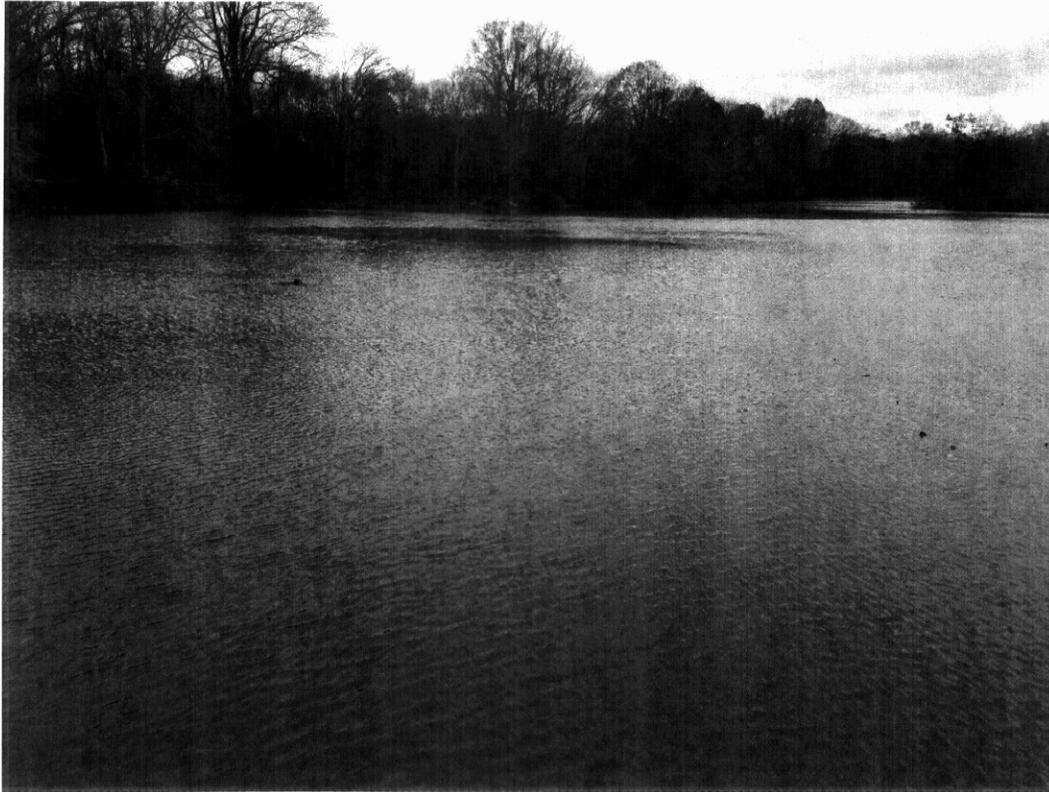
Photo 23: Overview of Red Valley Lake.
